Technical Inspection Report  
Bureau of Ordnance Group

OPERATION CROSSROADS.

TESTS 'A' AND 'B'.  
VOLUME III.  
PART I.  
Photographic  
Appendix [u]. 8

Subject: Bureau of Ordnance Material Group Final Report for Tests "A" & "B".

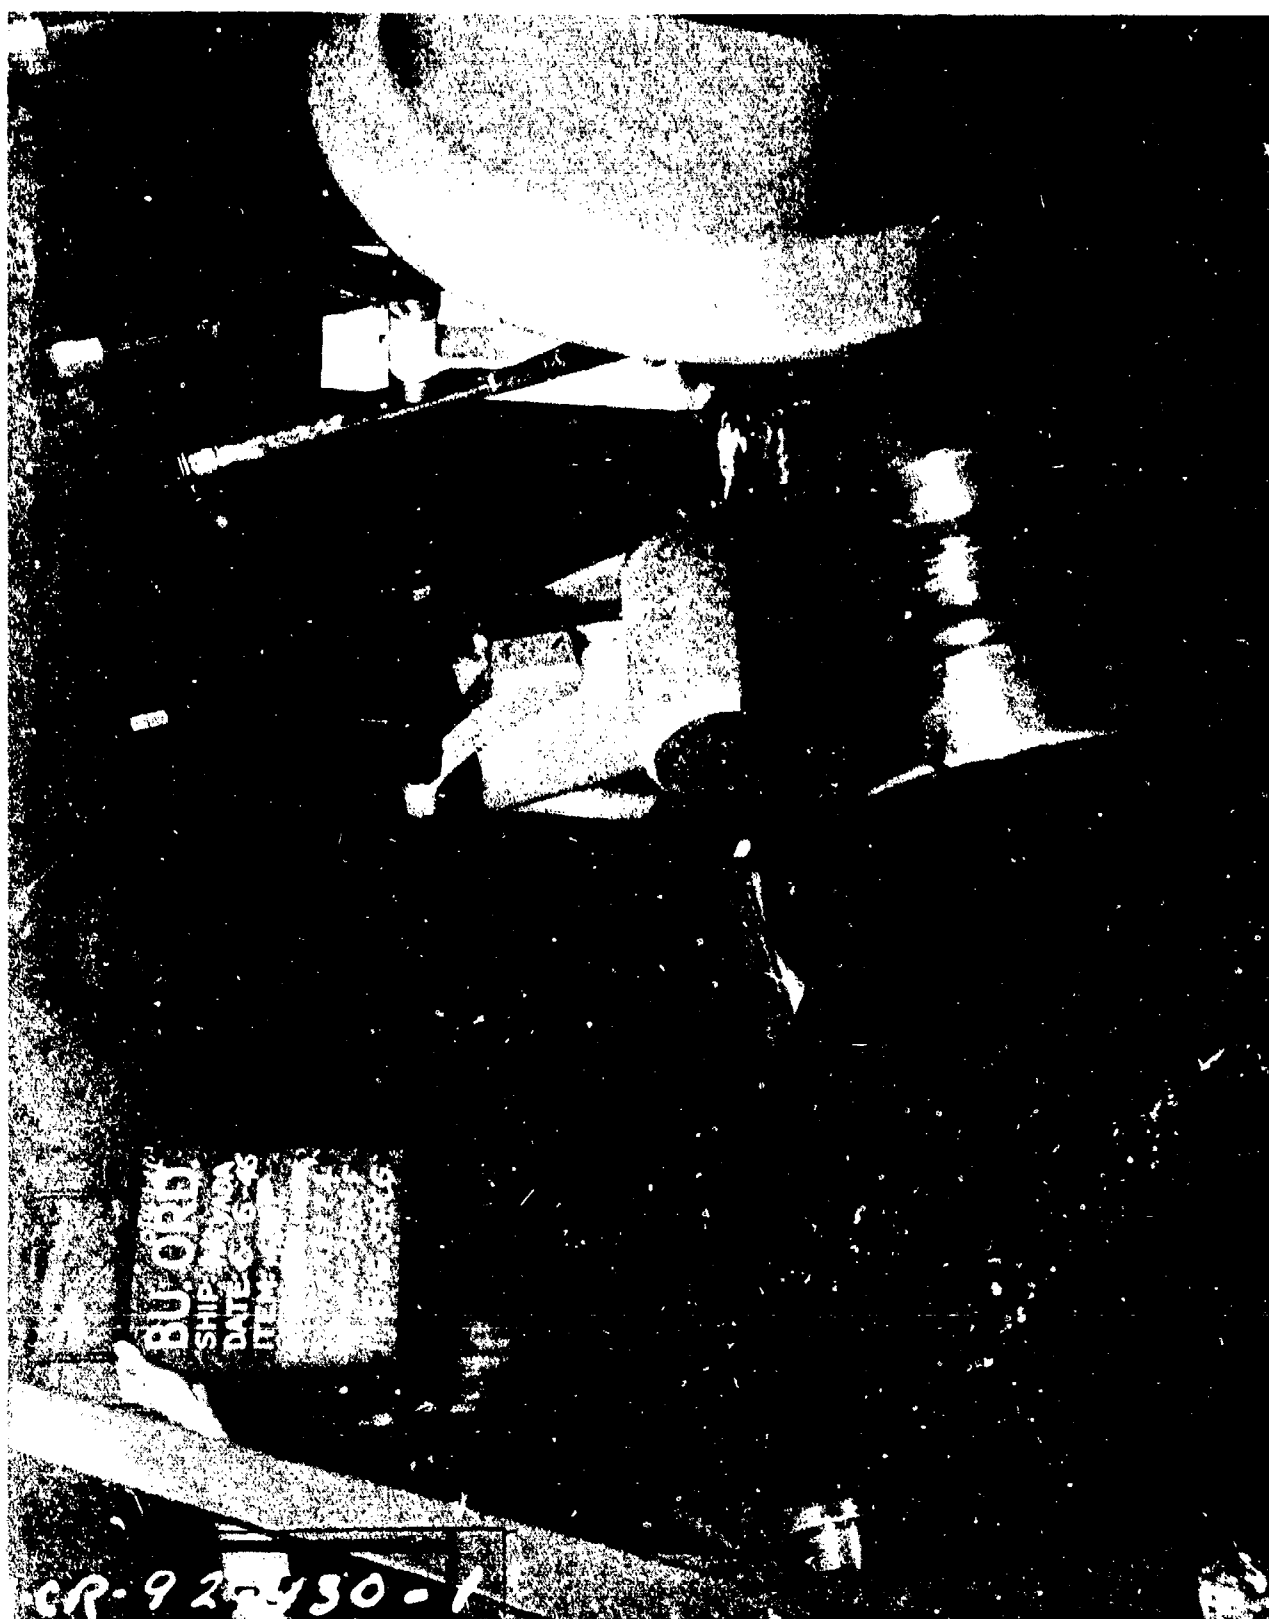
U.S.S. PLYMIA (BB-36) - Before Able  
Shows the Special Test Ammunition in position in  
Turret No. 4 prior to Test "A".  
Photo. No. BA-CR-92-430-1.

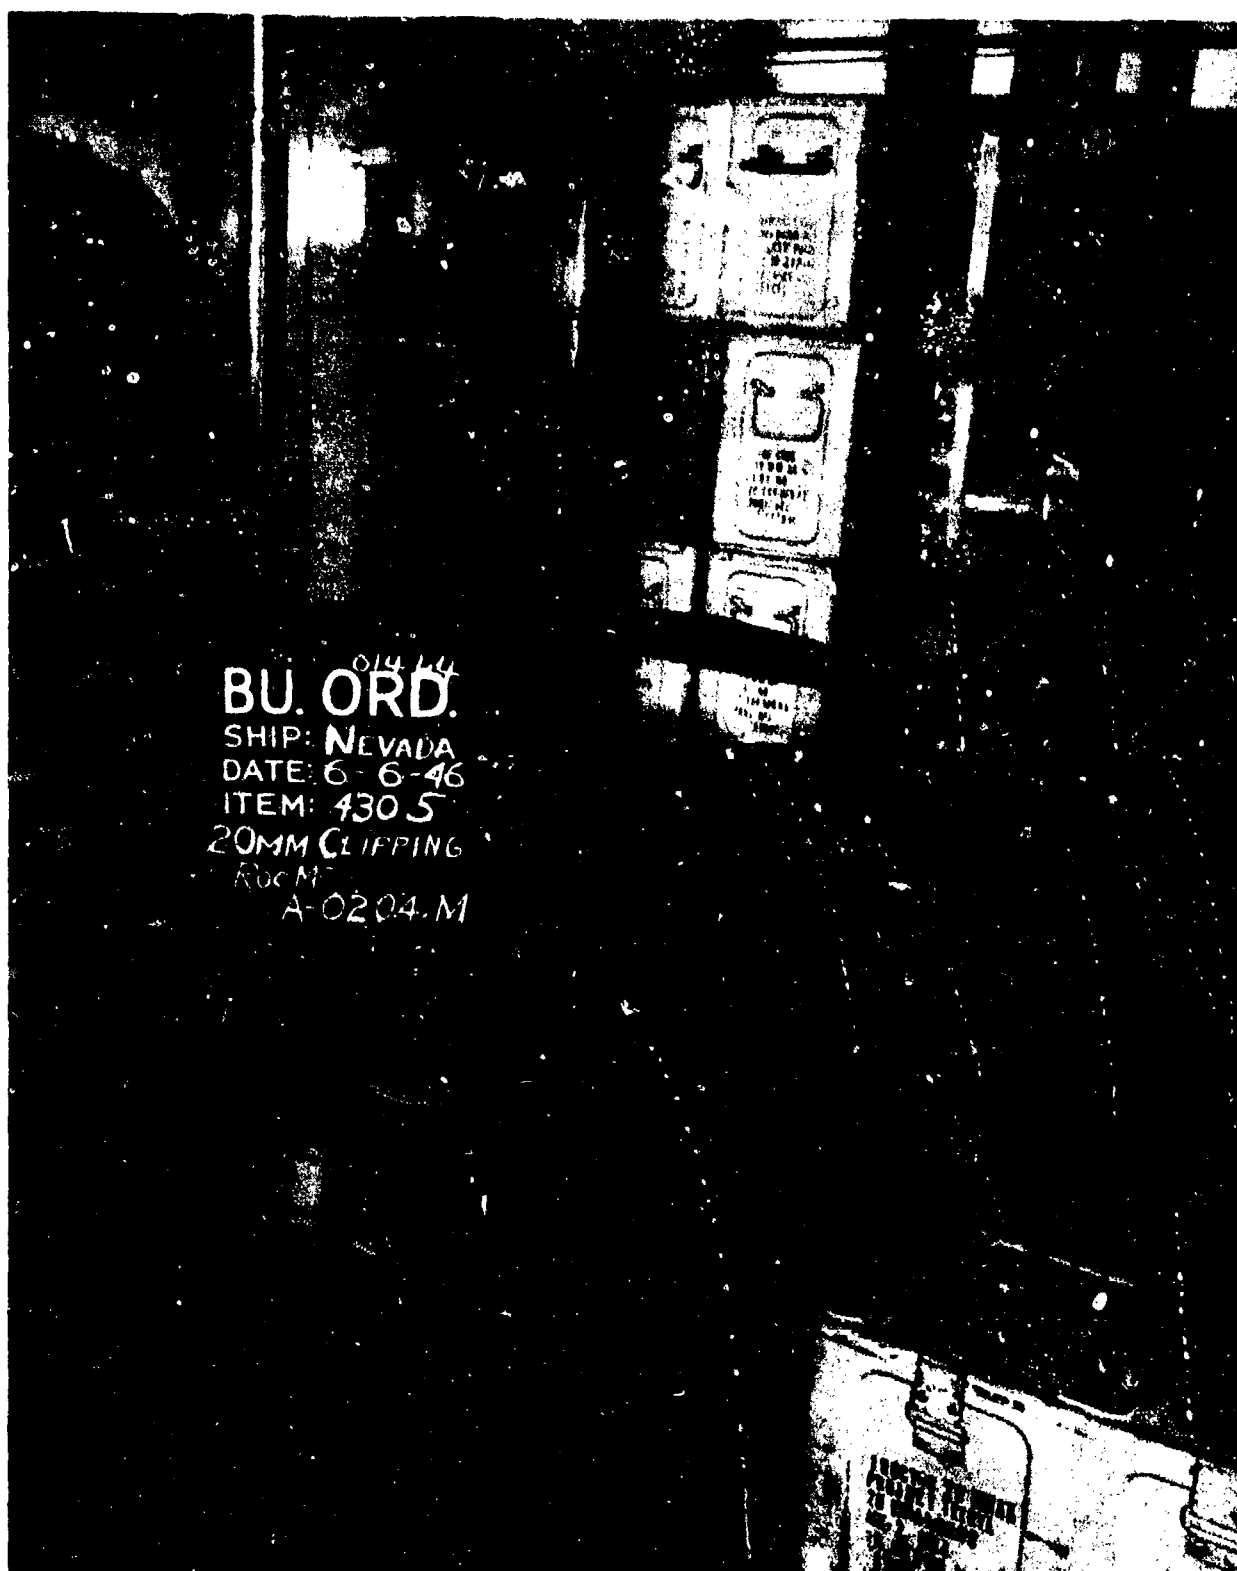
U.S.S. NEVADA (BB-36) - Before Able  
Shows the 20 MM Clipping Room, A-0204-M, prior to Test "A".  
All ammunition in photo is Service Ammunition.  
Photo. No. BA-CR-92-430-5.

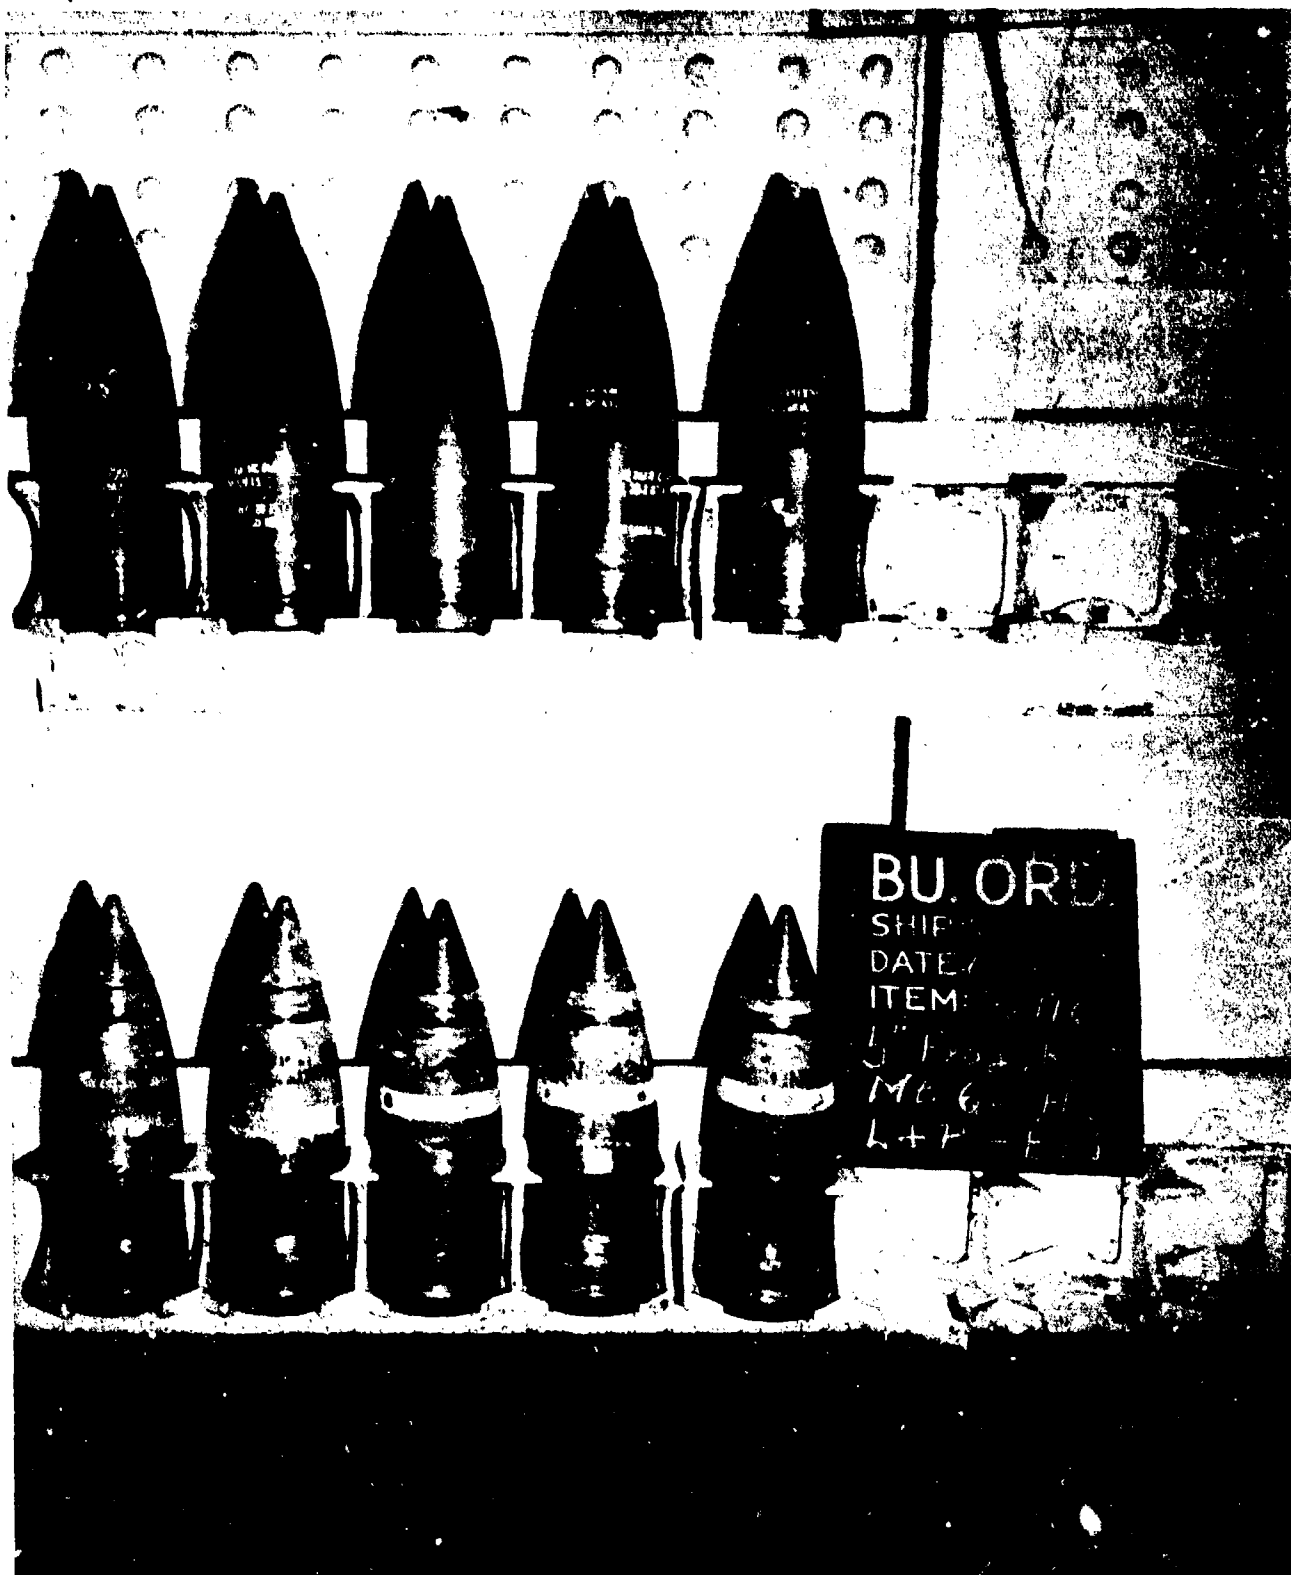
U.S.S. NEW YORK (BB-34) - Before Able  
Shows the 5"/51 Ready Service Projectile Stowage  
in Mount No. 6. Ammunition as shown in the photo is  
a Special Test Ammunition.  
Photo. No. BA-CR-97-961-10.

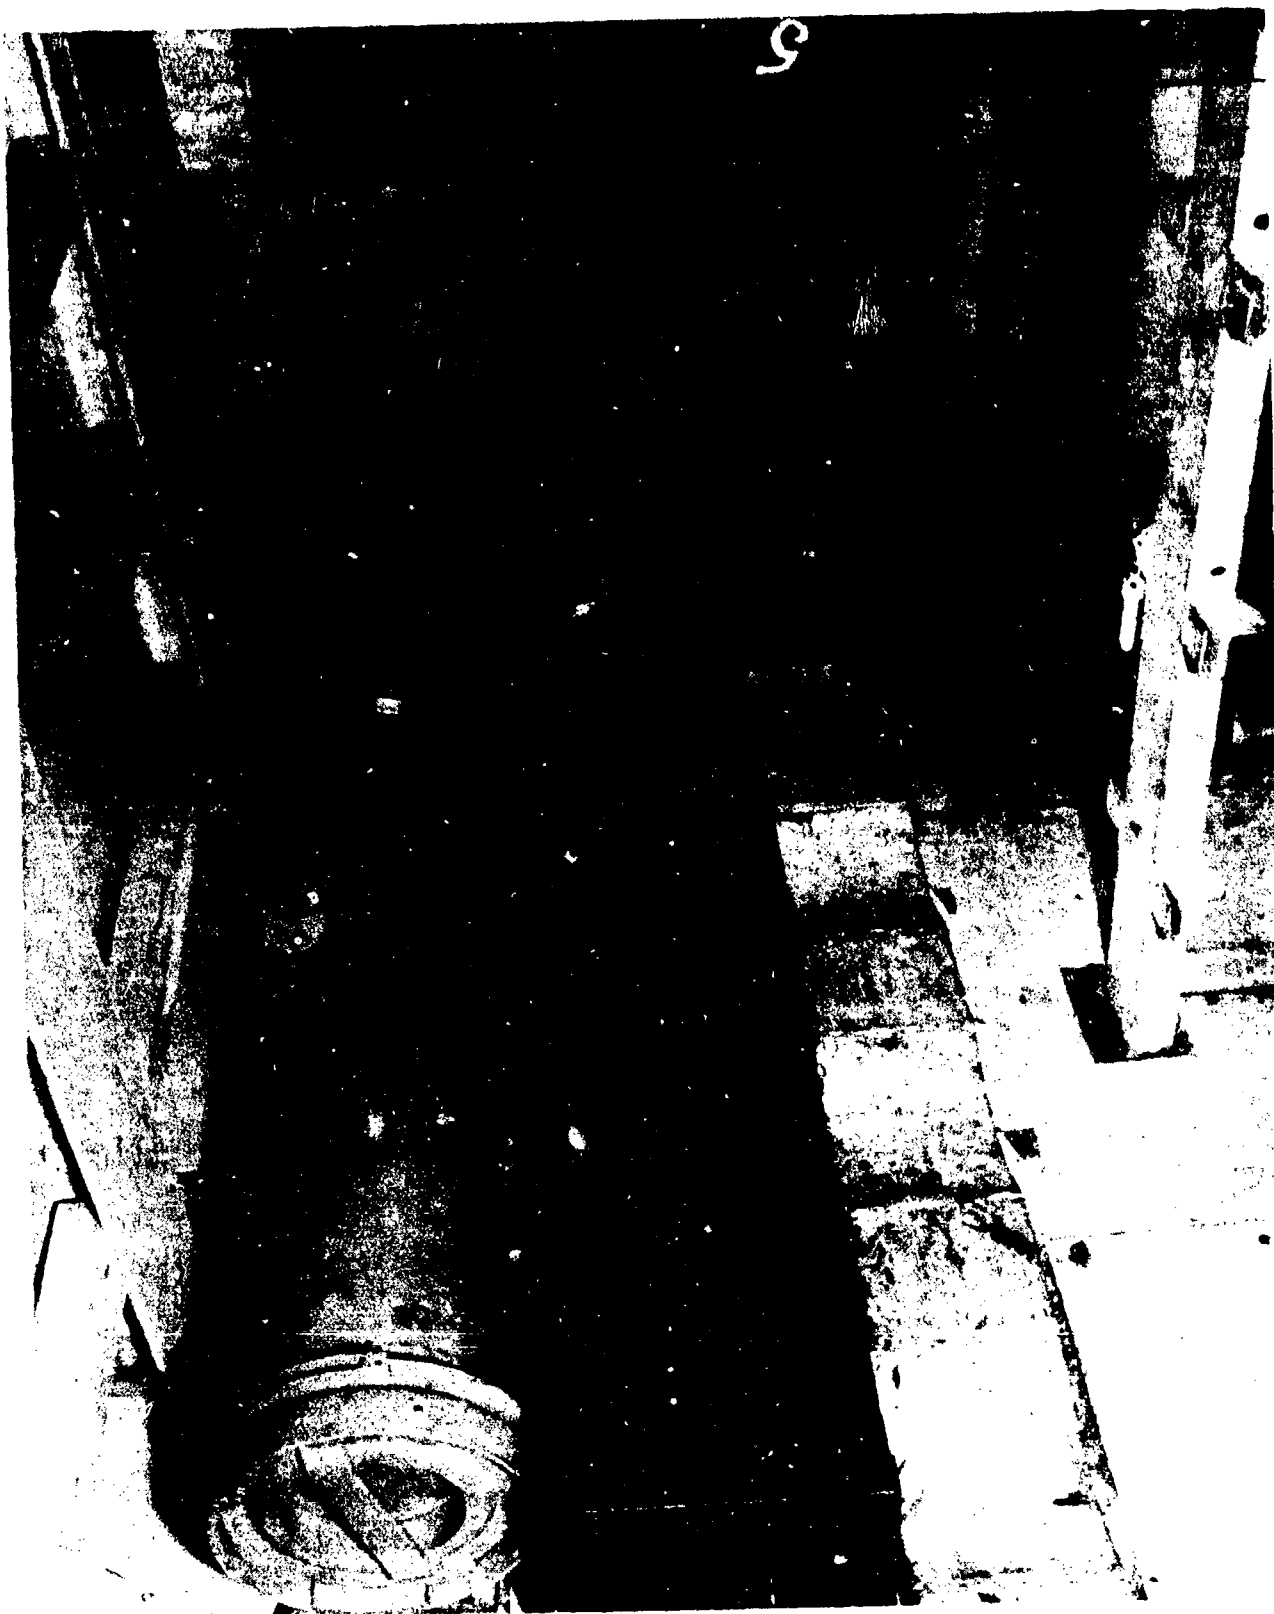
U.S.S. NEW YORK (BB-34) - Before Able  
Shows the Aircraft Bomb Stowage in Magazine, C-32-M,  
prior to Test "A". All ammunition is Service Ammunition.  
Photo. No. BA-CR-97-971-5.

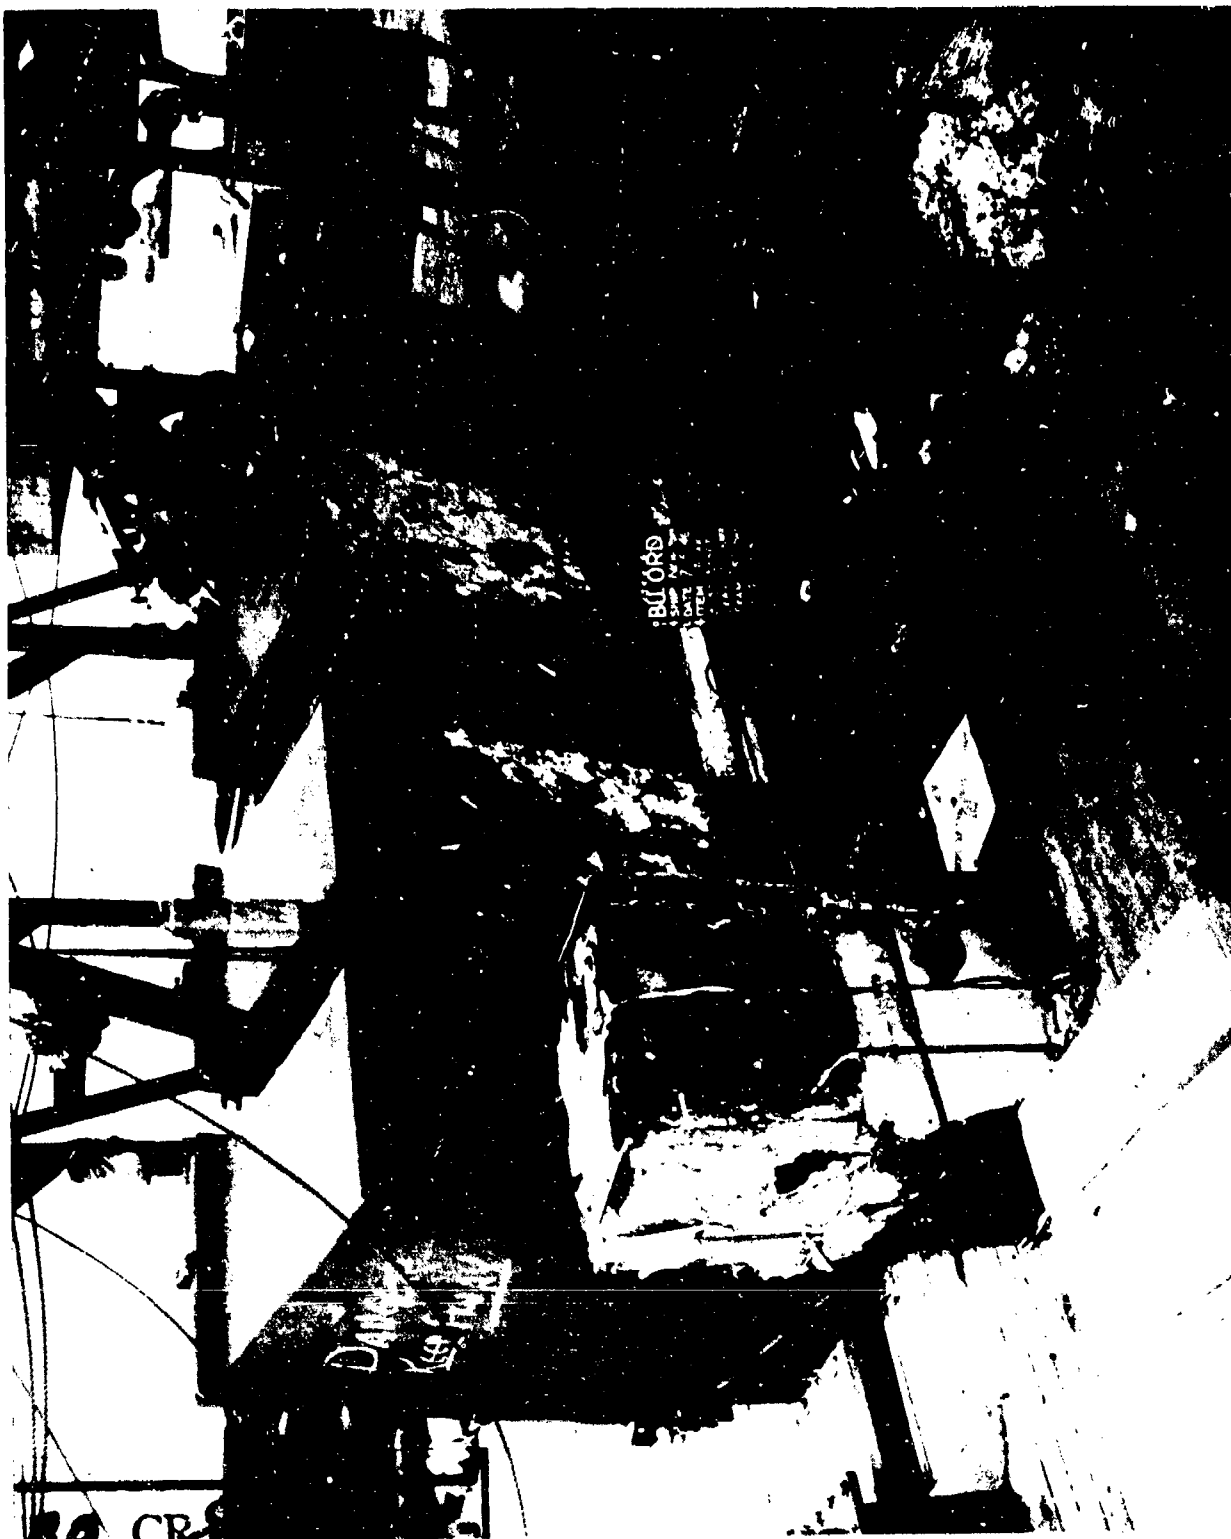
U.S.S. NEW YORK (EB-34) - After Able  
Shows the intensity of heat subjected to the 3"/50 Ready Service Lockers from burning  
Army Quartermaster Materials on display. The Maximum and Minimum Thermometer inside  
the lockers were ruptured from expanding mercury indicating that the ammunition had  
withstood exceedingly high temperatures. Surveillance test of the smokeless powder  
revealed no change.  
Photo. No. AA-CR-87-2540-7.

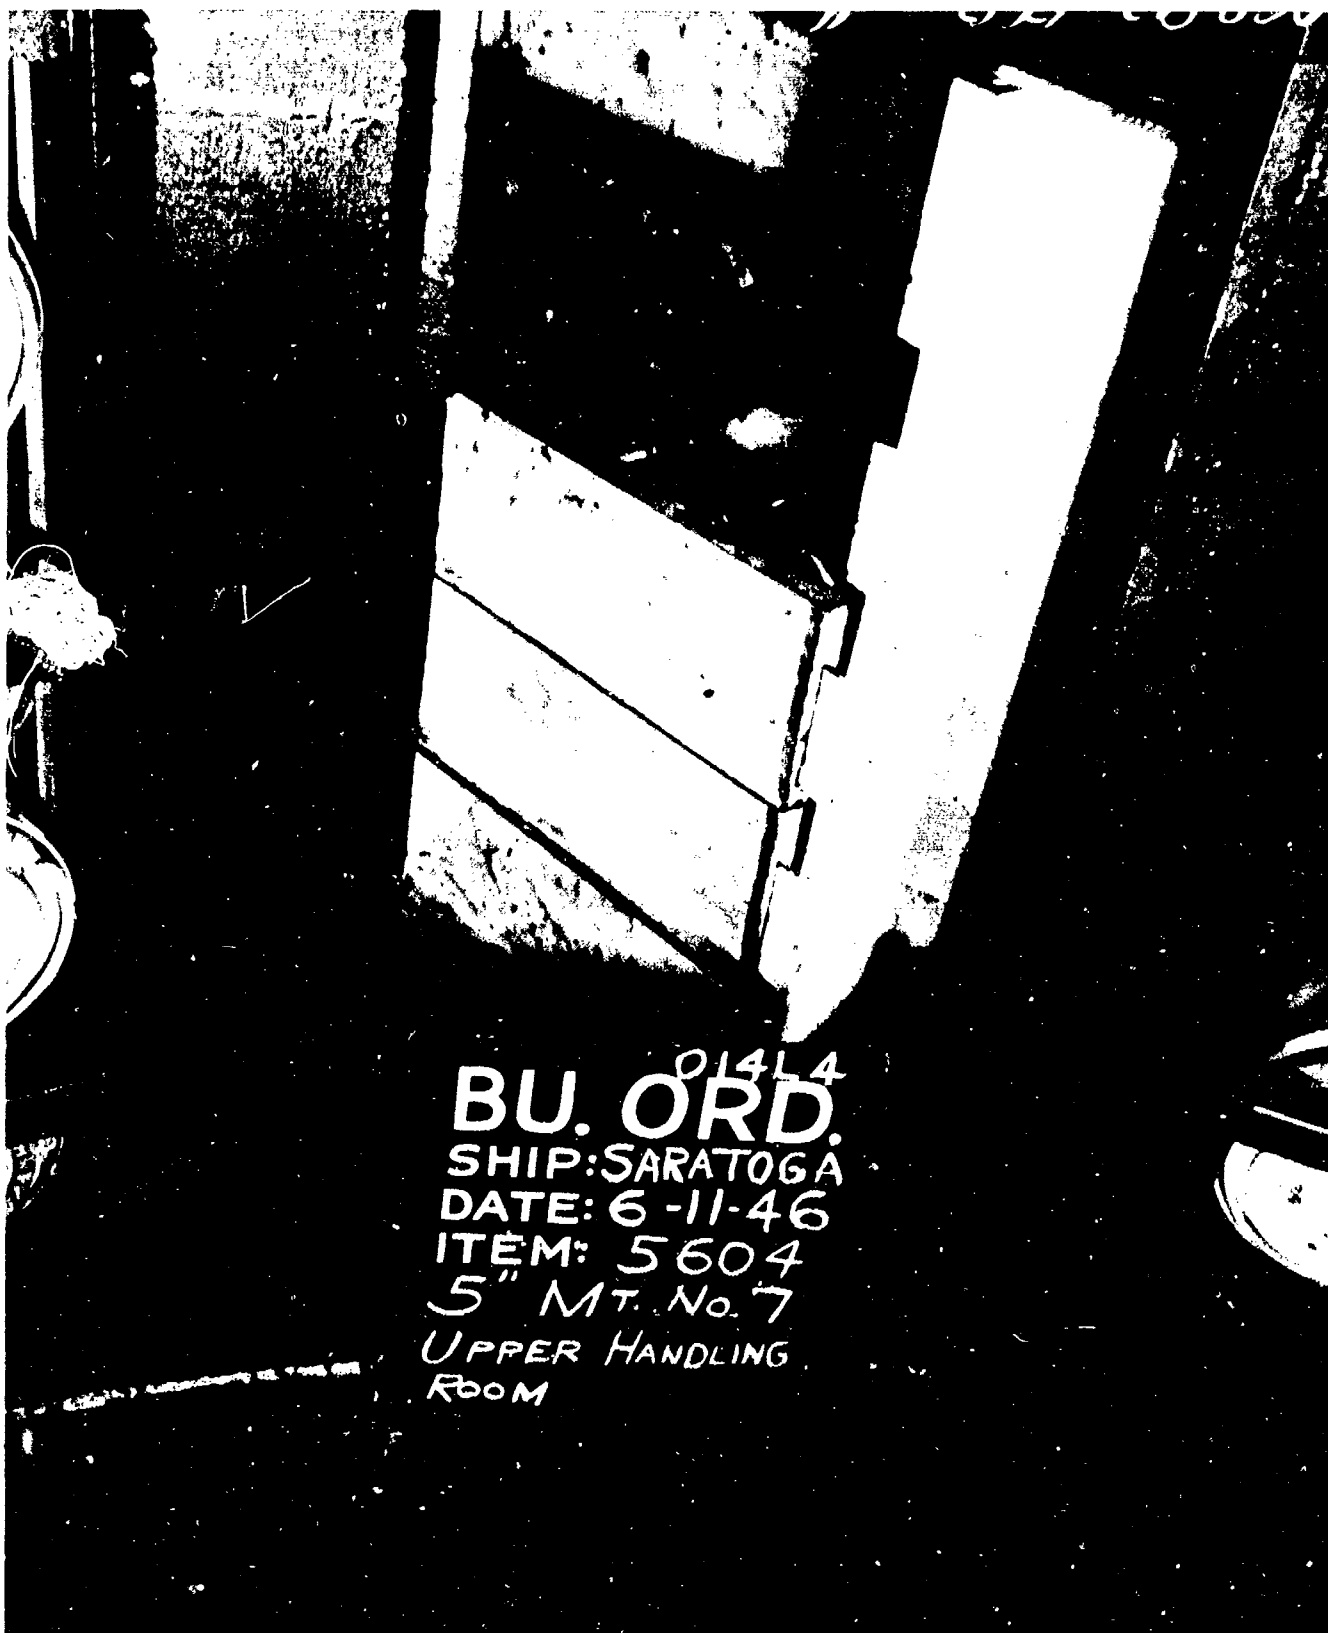
U.S.S. SARATOGA (CV-3) - Before Attle  
 Shows the upper 5"/38 handling room for Mount 7 prior  
 to Test "A".  
 Photo. No. PA-OR-92-548-7.

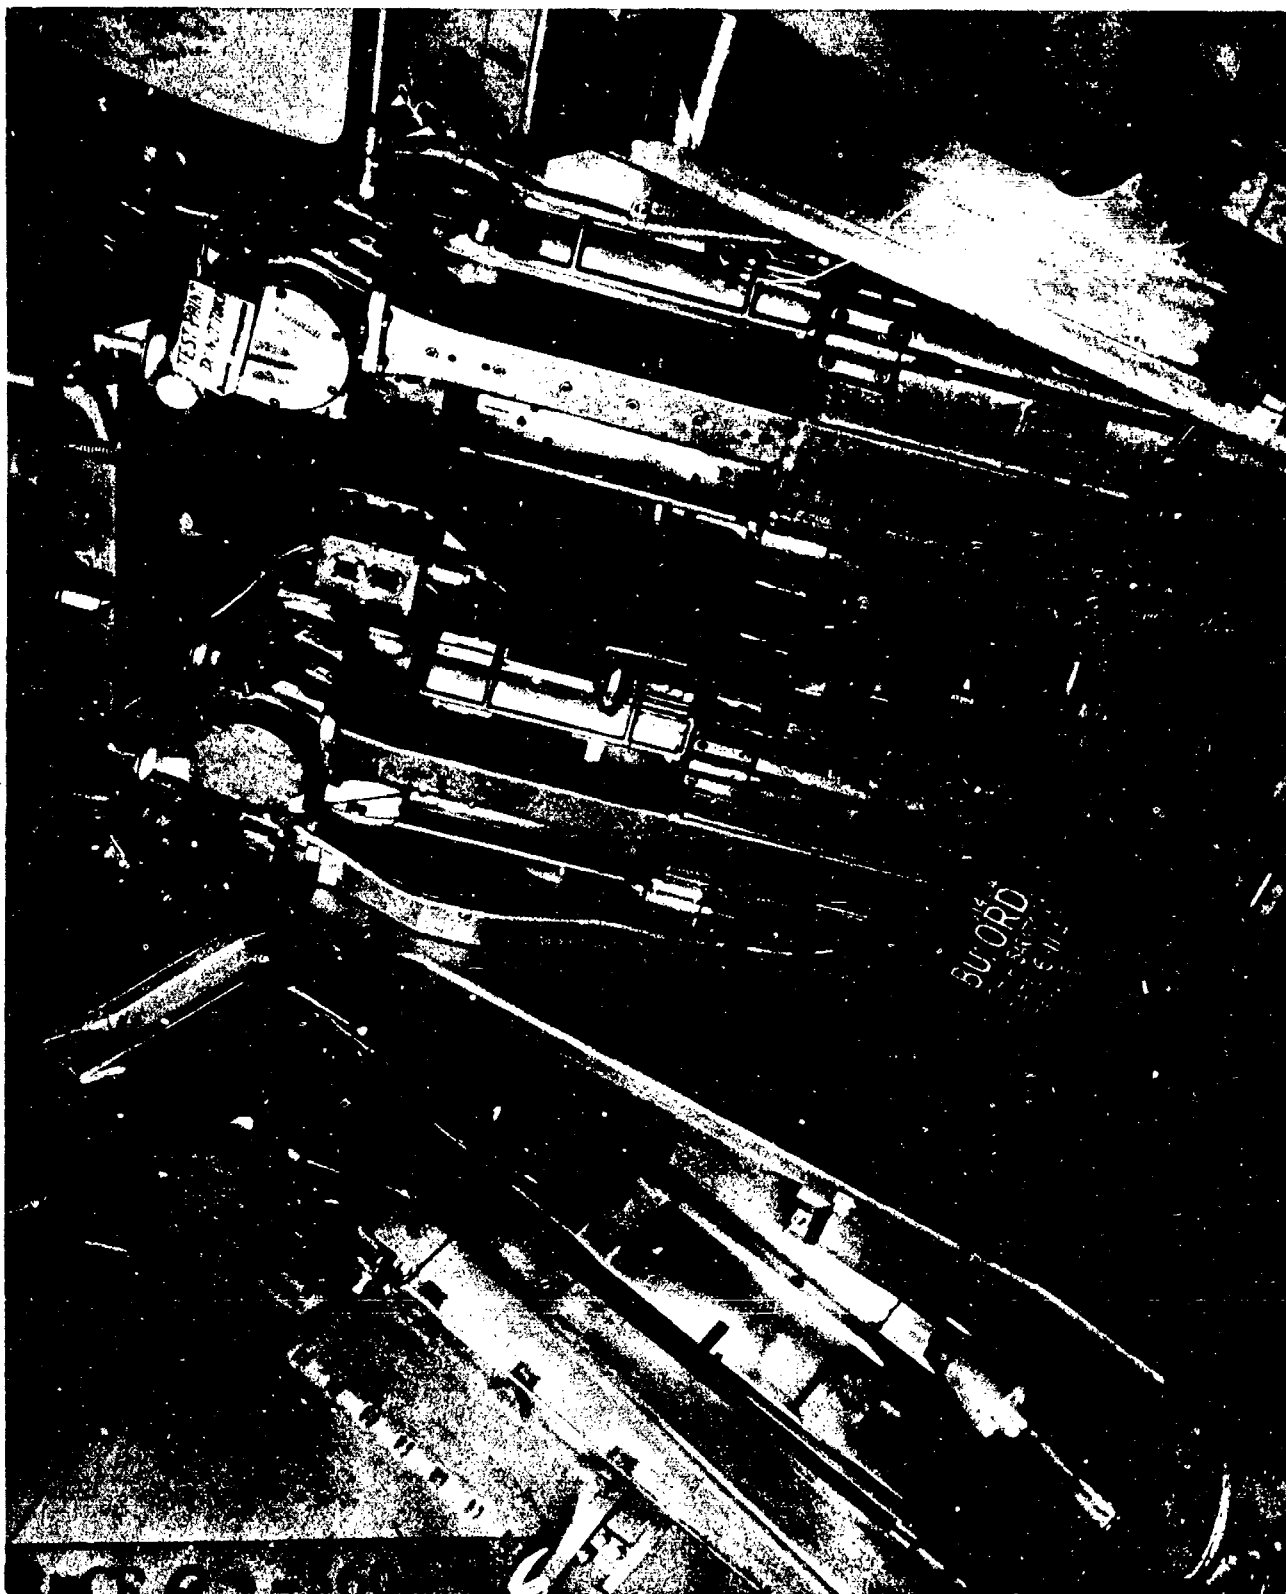
U.S.S. SARAPOA (CV-3) - Before Able  
Shows the (L&F) Special Test Ammunition in position  
in Mount, No. 7 prior to Test "A".  
Photo. No. BA-GH-92-560-6.

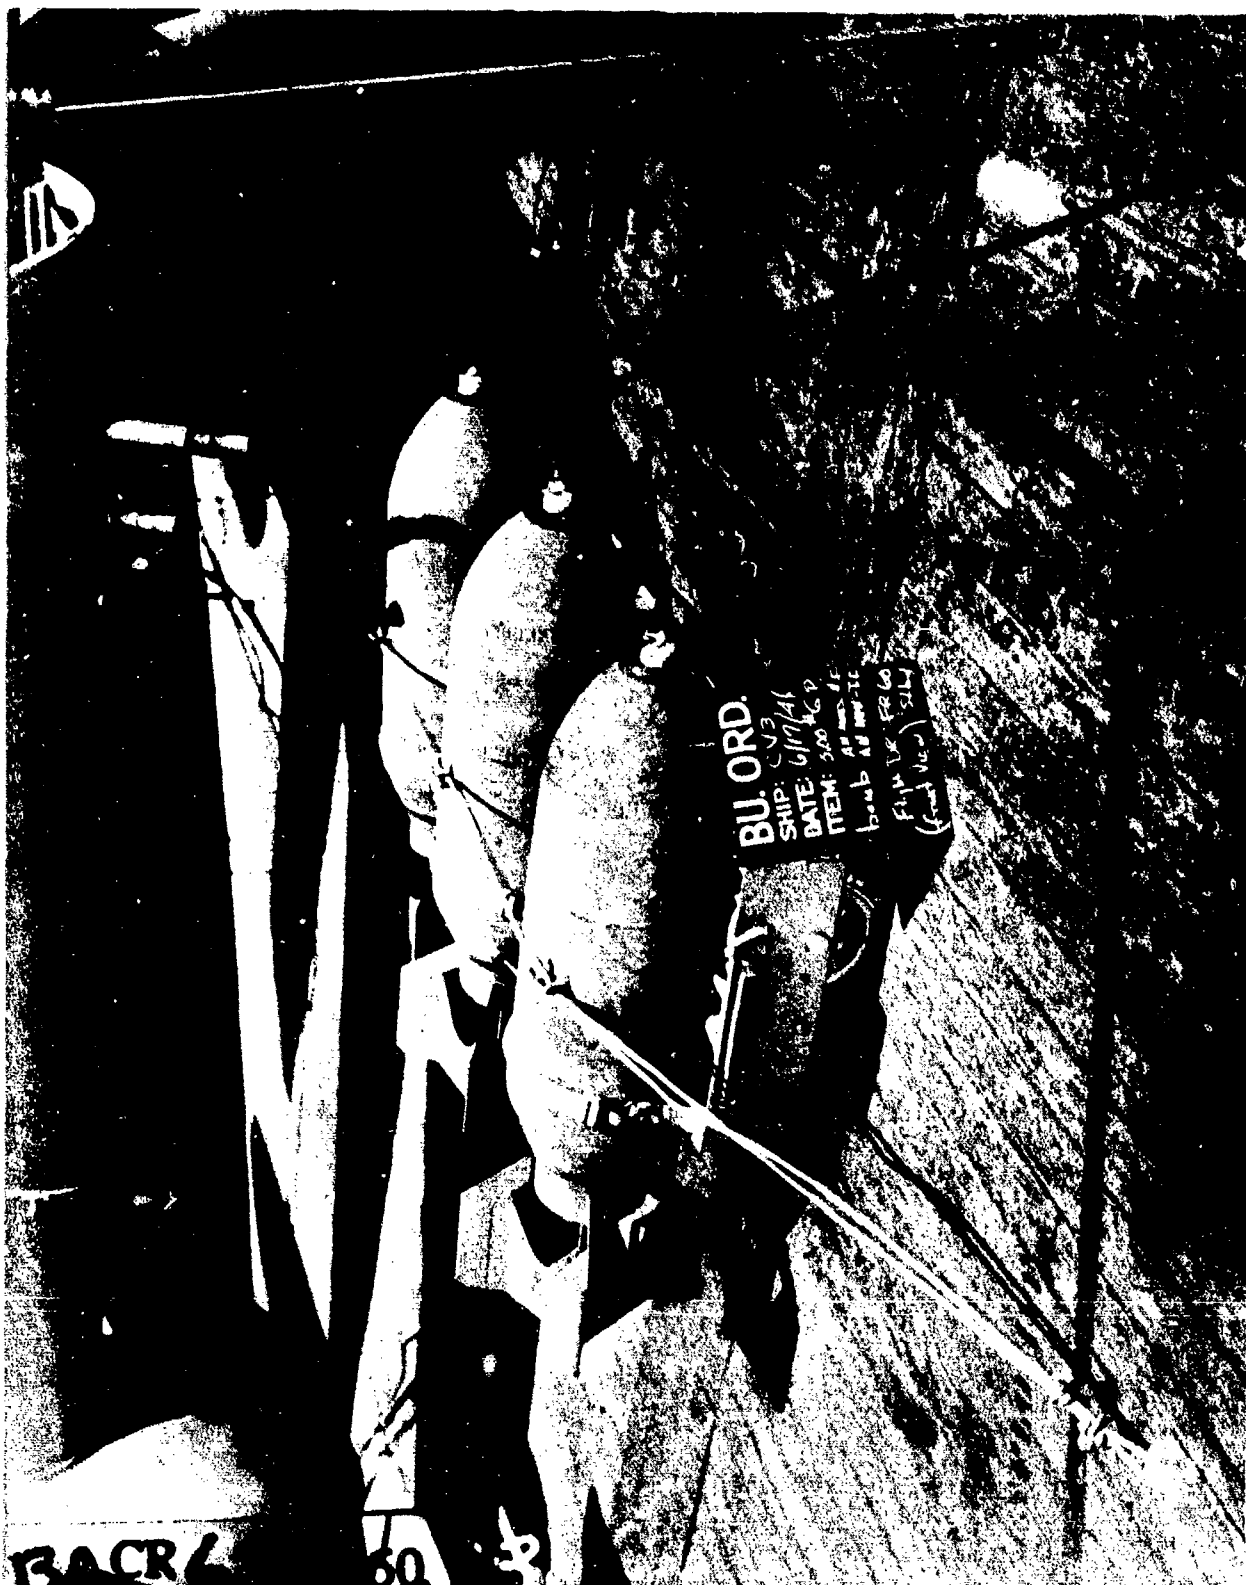
U.S.S. SARATOGA (CV-3) - Before Able  
Shows the 500 lb., general purpose, aircraft bombs,  
AN-M64A1, plaster loaded and fuzed, in position prior to Test "A".  
Photo. No. DA-CR-63-1560-3.

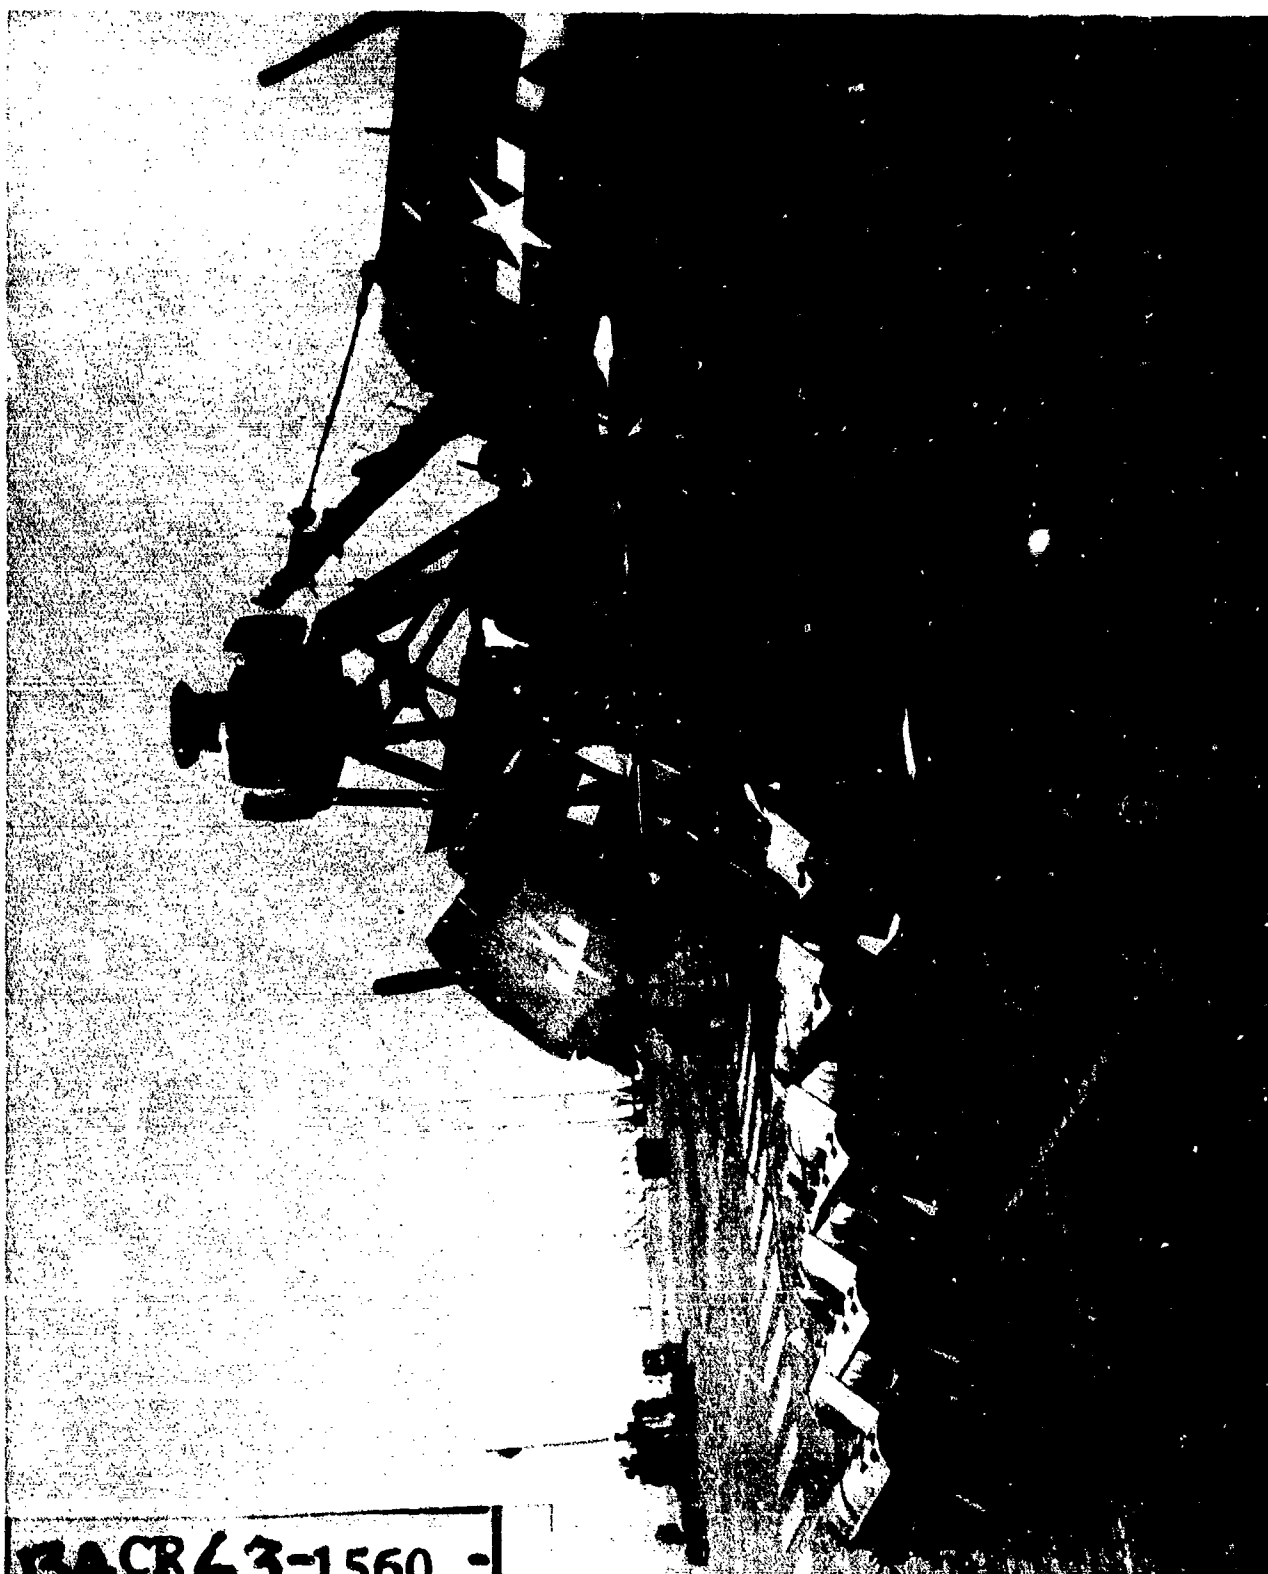
U.S.S. SARATOGA (CV-3) - Before Able  
Shows the 11".75 Aircraft Rocket (Tiny Tim) in position  
for Test "A". The complete rocket was inert.  
Photo. No. BA-CR-63-1560-7.

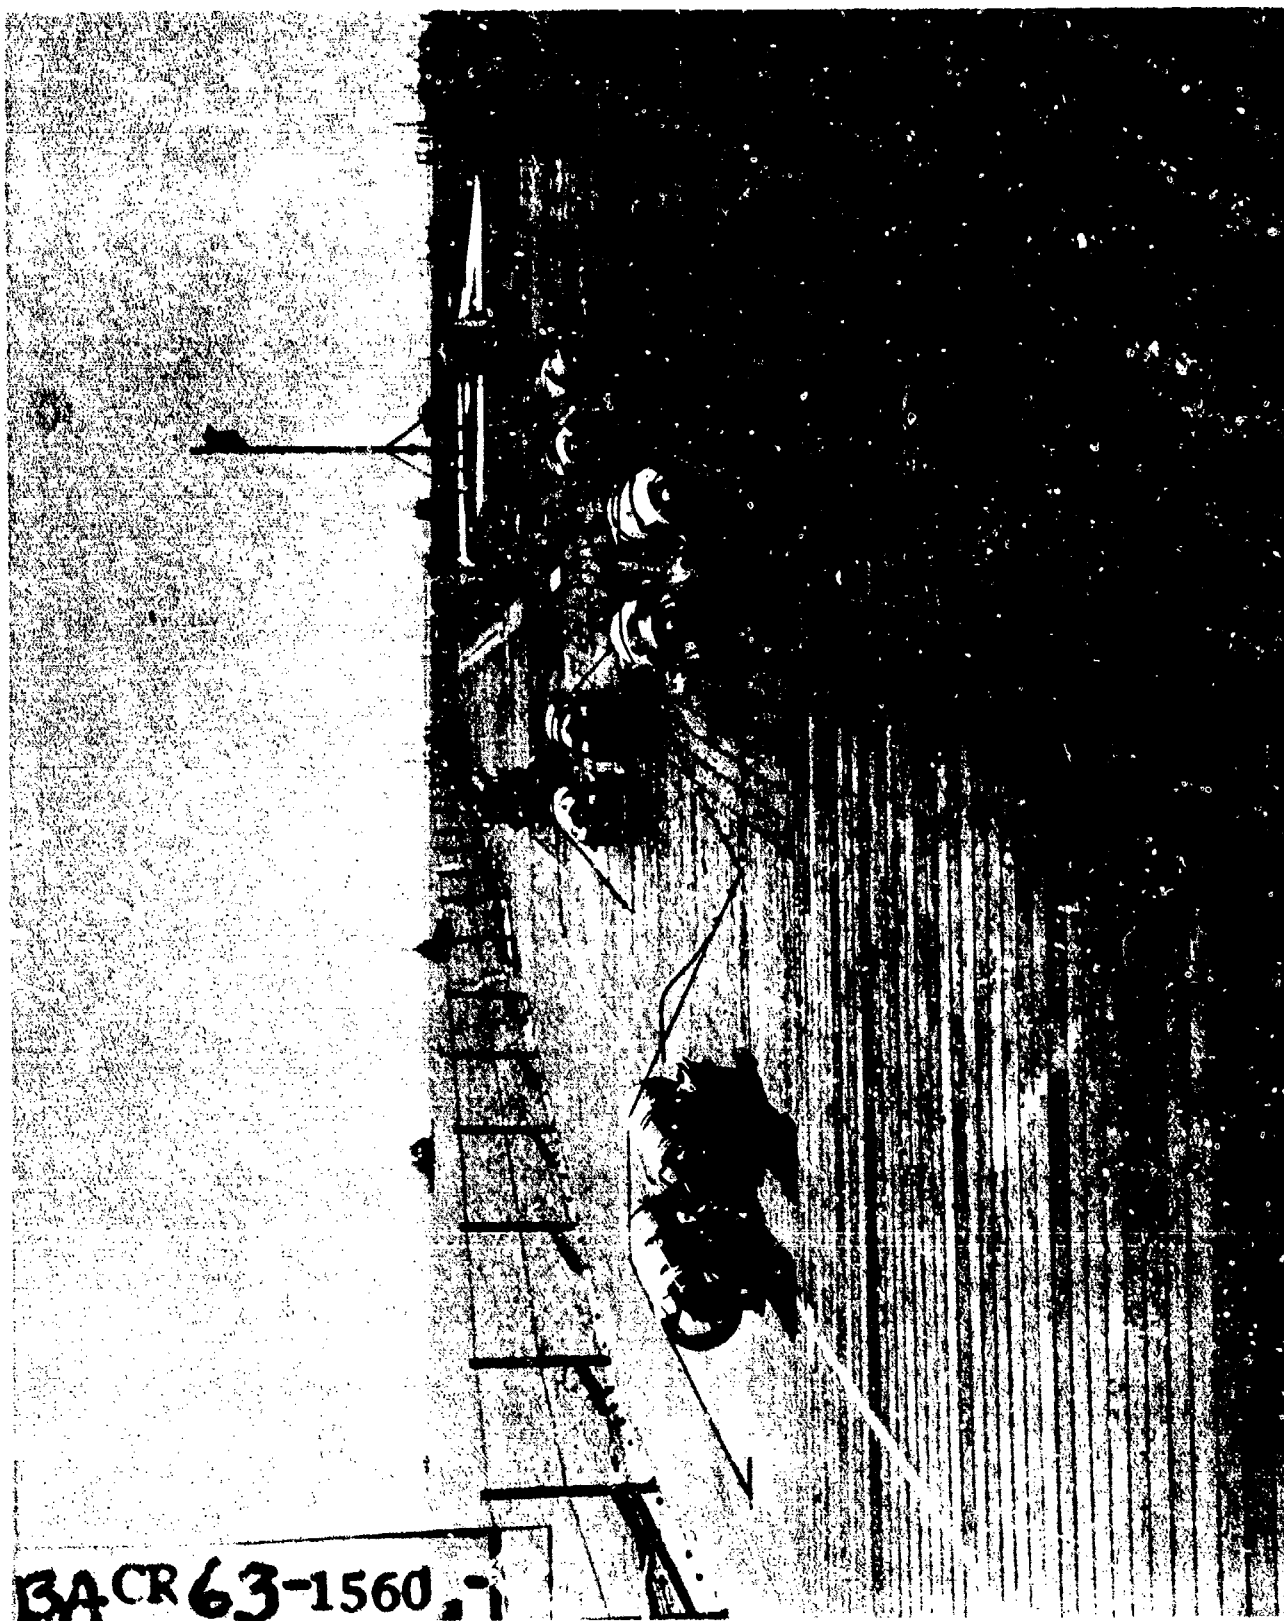
BA CR 63-1560.

U.S.S. SARATOGA (CV-3) - Before Able  
Shows the 350 lb., aircraft depth bombs, Mark. 10 Mod. 3,  
plaster loaded and fuzed, in position prior to test "A".  
Photo. No. BA-AR-63-1560-9.

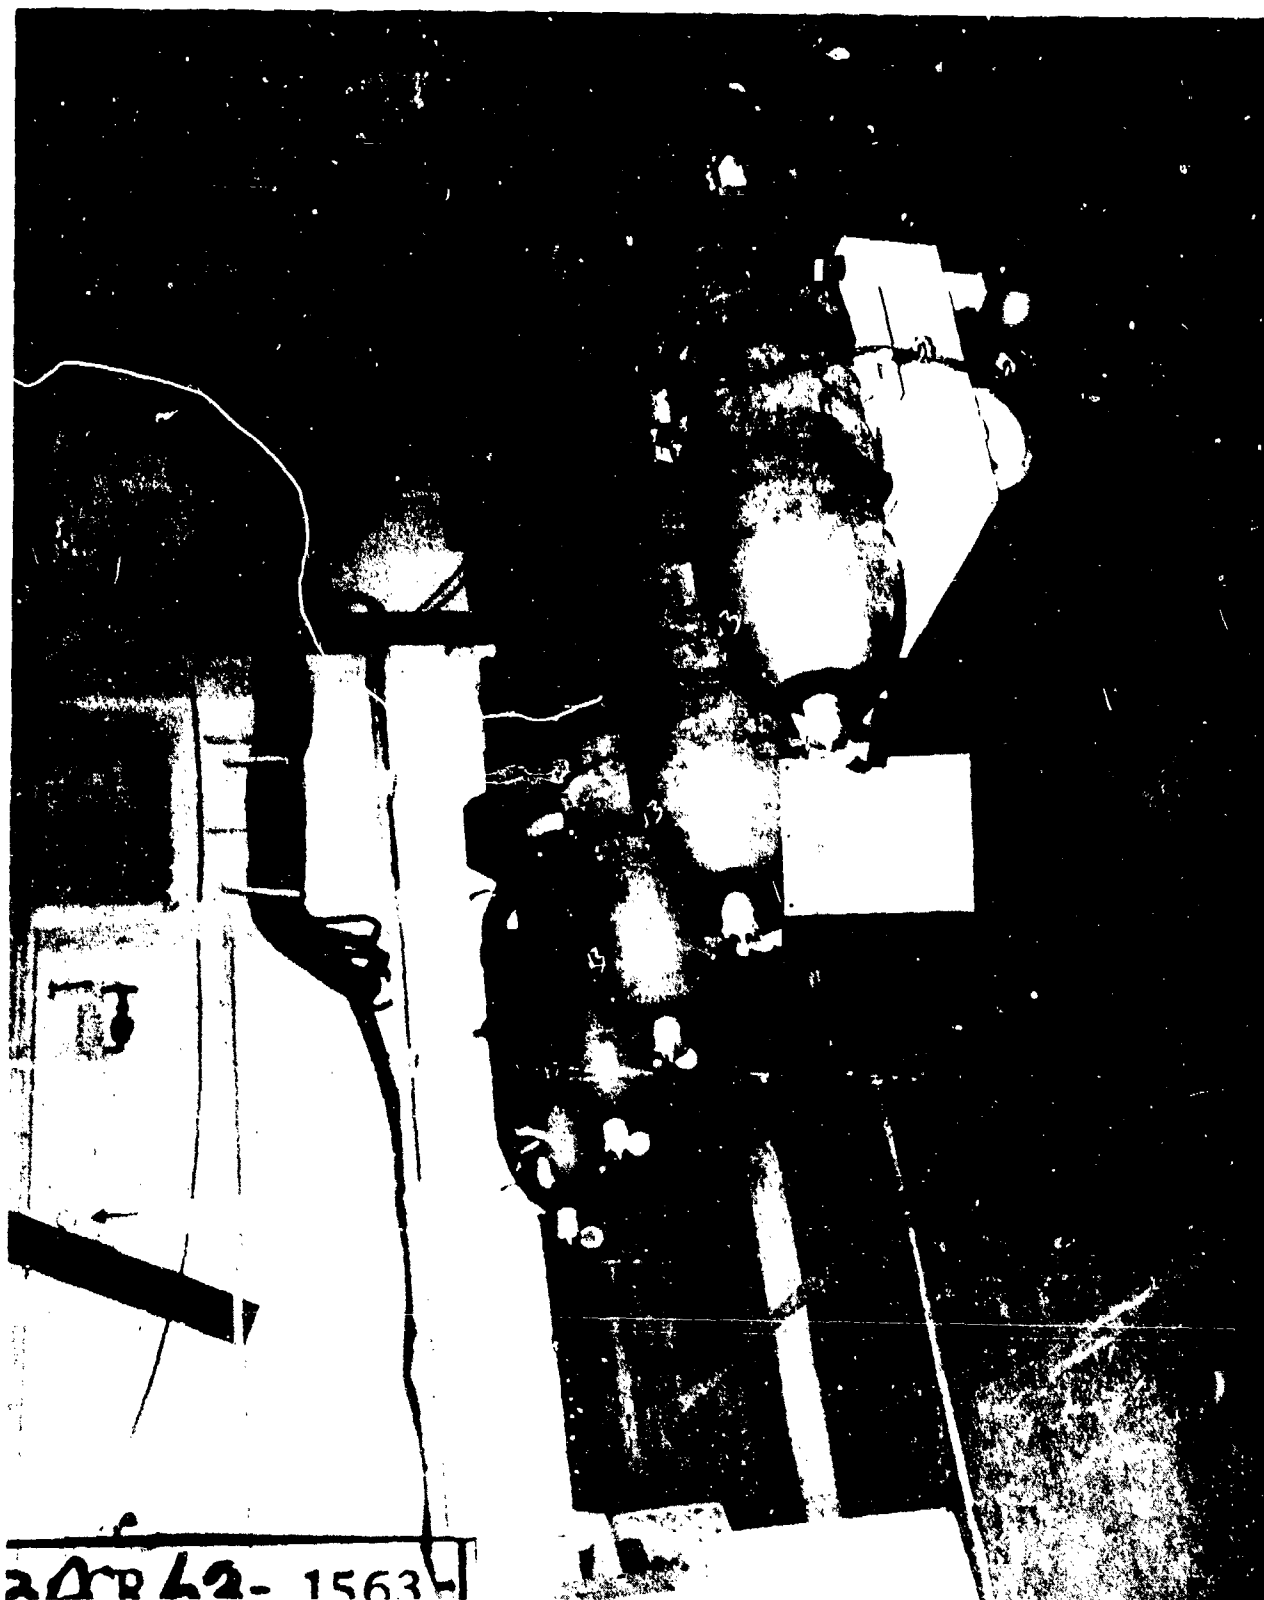
U.S.S. SARATOGA (CV-3) - Before Able  
Shows the 500 lb., general purpose, aircraft bomb, AN-M6/A1,  
plaster loaded and fuze in position prior to Test "A".  
Photo. No. BA-Ch-63-1563-4.
